GEORGIA INSTITUTE OF TECHNOLOGY

Subject: Monthly Letter 1, Project A-925
"Rain Erosion Sled Testing of Slip-Cast Fused Silica Radomes"
Contract No. DA-01-021-AMC-14464 (Z)
Covering the Period from March 1 to March 31, 1966

This report describes a rocket sled test program which was conducted to determine the rain erosion resistance of slip-cast fused silica at velocities above 5000 feet per second. The fabrication techniques used at the Georgia Institute of Technology to slip-cast, heat treat and flame glaze the radomes are discussed. The results of the six sled tests which were run at Holloman Air Force Base, New Mexico, and which covered distances up to 4000 feet in an artificial rain field of 2-1/2 inches per hour are presented. The failure of two radomes to survive rain damage for distances between 2000 and 4000 feet in the rain field is attributed to the severe mechanical environment which results from sled vibration. This condition is considered extremely unrealistic with respect to a missile flight situation. It is concluded that flame glazed slip-cast fused silica should survive a minimum of 4000 feet in a natural rain of 2-1/2 inches per hour under actual missile flight c

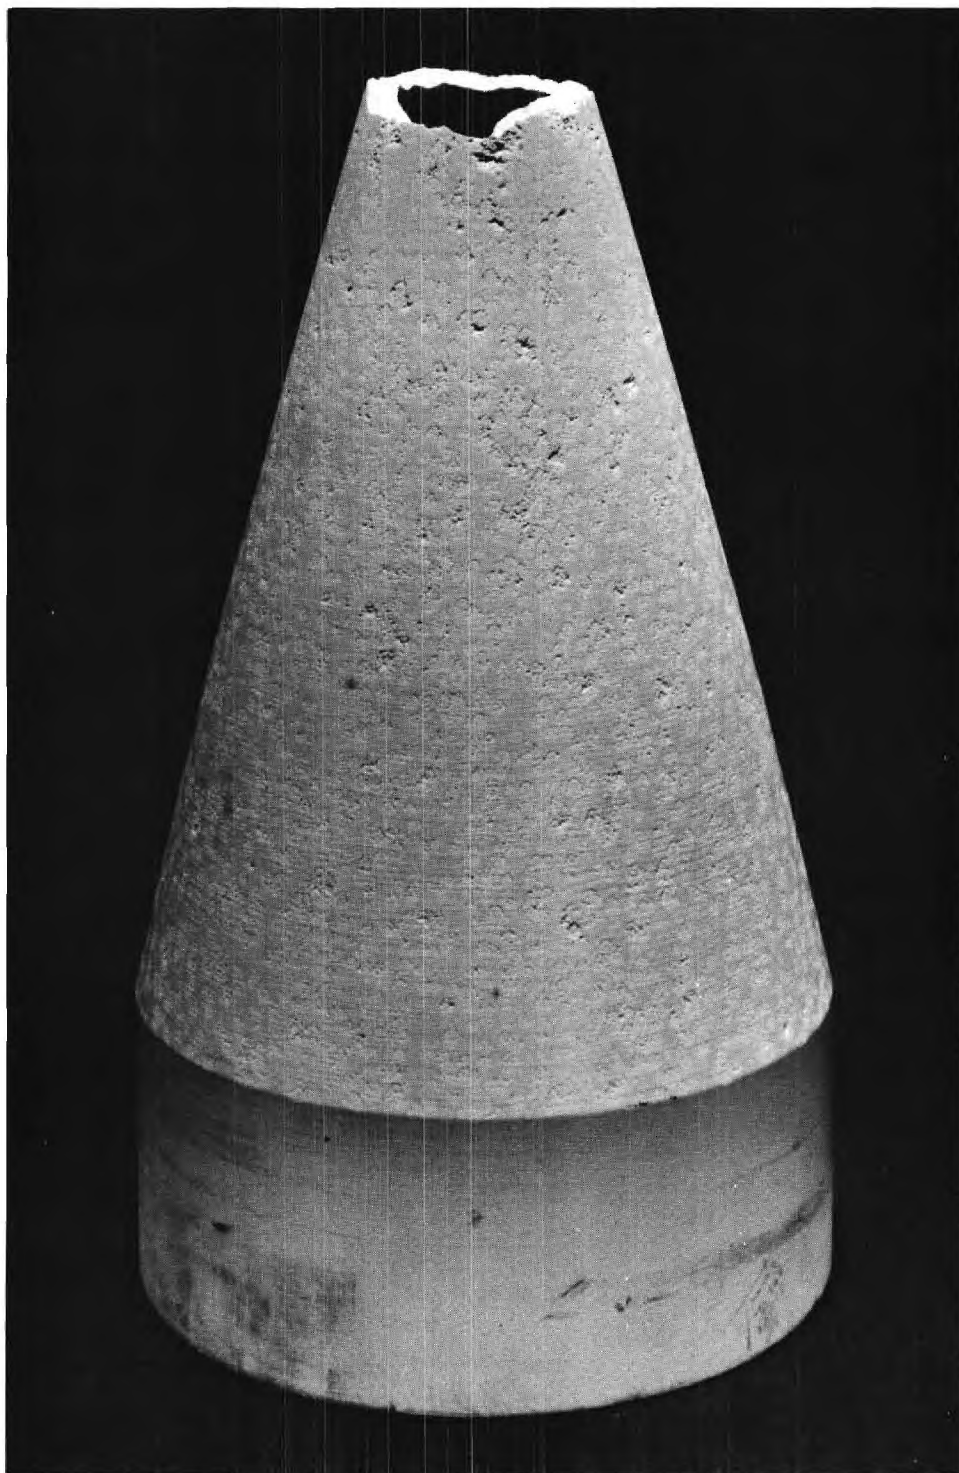
Figures 14 and 15 show radome No. 1411 after exposure to 800 feet of rain. The broken tip suggested that the radome probably broke during or upon leaving the rain field. At this time sled vibration would be at a maximum. However, from the image motion photograph shown in Figure 16 it can be seen that the radome was intact when it emerged from the rain field. It can also be seen that the drag brakes (cylindrical piece protruding from the side of the sled just aft of the transition piece which connects the radome to the sled) are almost completely extended. This information suggested that the radome tip probably survived the high velocity portion of the flight and that the portion of the radome may have come off as a result of the high deceleration associated with the sled hitting the water brake. Subsequent search of the water brake area uncovered the broken tip about 800 feet from the point where the sled first encountered the water brake.

Figure 14. Radome on Sled after 800 Feet of Rain in Run No. 3 (7RC1).

Figure 15. Side View of Radome from Run No. 3 (7RC1).

The surface damage caused by the 800 foot rain field in Run No. 3 was as expected from the 400 foot run. It was first assumed that the tip of the radome was lost in the rain or just as the radome emerged from the rain. This would be at the time of maximum vibration. From Figure 16 it was noted that the radome was still in one piece after leaving the rain field, and had therefore, survived the vibration associated with the peak velocity. The next point of high acceleration would be upon sled impact with the water brake. A search of this area uncovered the tip about 800 feet from the point of water brake impact. This suggested that the tip of the radome was essentially pulled away from the rest of the radome. Examination of the radome revealed that the wall thickness in the area of failure was between 0.305 and 0.350 inch. This was only one-half the thickness of the radome just 4 inches aft of this area. For some unexplained reason the wall thickness tapered uniformly from about 0.600 inches at a point about 9 inches from the base of the radome to about 0.300 inches at a point 13 inches from the base. After determining these facts, it was surprising that the radome survived the vibration associated with the peak velocity and the accompanying rain impact. One further observation was made at the track. The slippers on the sled for this run were exceptionally tight. It was only with a great deal of effort that the track crew was able to get the sled on the track. If this tight fit reduced the sled vibration it might explain why the radome survived the maximum velocity through the rain.

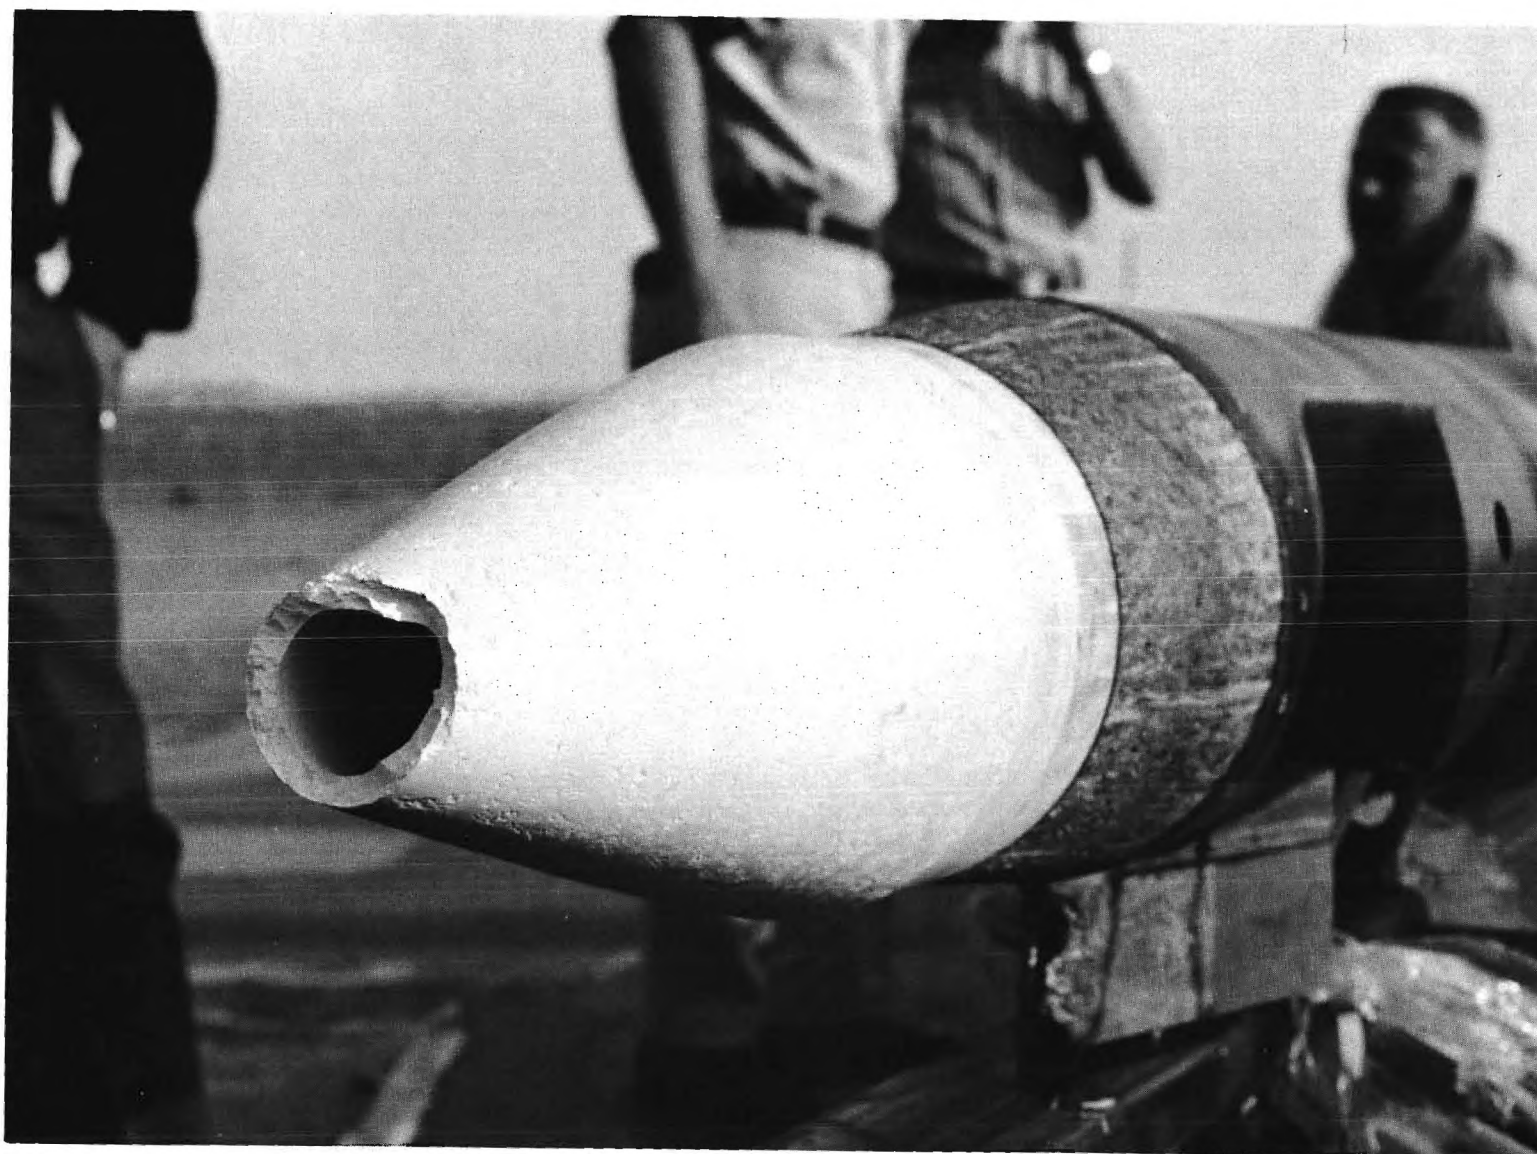
Figure 14. Radome on Sled after 800 Feet of Rain in Run No. 3 (7RC1).

Figures 14 and 15 show radome No. 1411 after exposure to 800 feet of rain. The broken tip suggested that the radome probably broke during or upon leaving the rain field. At this time sled vibration would be at a maximum.

The surface damage caused by the 800 foot rain field in Run No. 3 was as expected from the 400 foot run. It was first assumed that the tip of the radome was lost in the rain or just as the radome emerged from the rain. This would be at the time of maximum vibration. From Figure 16 it was noted that the radome was still in one piece after leaving the rain field, and had therefore, survived the vibration associated with the peak velocity. The next point of high acceleration would be upon sled impact with the water brake. A search of this area uncovered the tip about 800 feet from the point of water brake impact. This suggested that the tip of the radome was essentially pulled away from the rest of the radome. Examination of the radome revealed that the wall thickness in the area of failure was between 0.305 and 0.350 inch. This was only one-half the thickness of the radome just 4 inches aft of this area. For some unexplained reason the wall thickness tapered uniformly from about 0.600 inches at a point about 9 inches from the base of the radome to about 0.300 inches at a point 13 inches from the base. After determining these facts, it was surprising that the radome survived the vibration associated with the peak velocity and the accompanying rain impact. One further observation was made at the track. The slippers on the sled for this run were exceptionally tight. It was only with a great deal of effort that the track crew was able to get the sled on the track. If this tight fit reduced the sled vibration it might explain why the radome survived the maximum velocity through the rain.
